DRON & DICKSON CABLE REPLACEMENT

Case Study

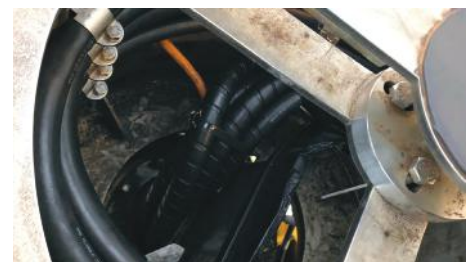
Internals of the Drag Chain - After

All existing glands, cables and associated materials were removed before installing new cables correctly within the Hydraracker unit.

- Highly trained personnel with CompEx and IRATA skills were deployed to complete the project on time and within budget
- Dron & Dickson supplied all materials for the project including cabling, cable glands, cable markers/consumables and containment
- Ten multicore cables were removed, replaced, glanded, terminated, labelled, tested and commissioned
- Onshore engineering support was provided as standard

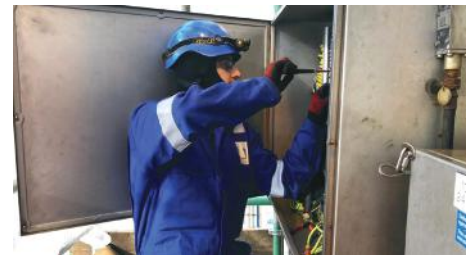
Technician Terminating Cables

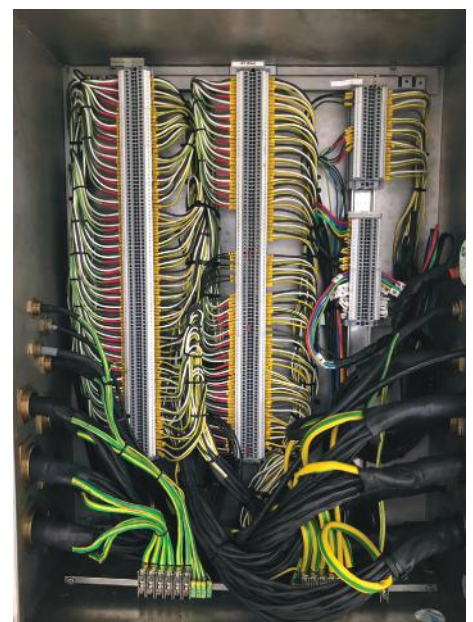
Marshalling Cabinet - After
