DRON & DICKSON

GAS DETECTOR REMEDIATION

Success Story

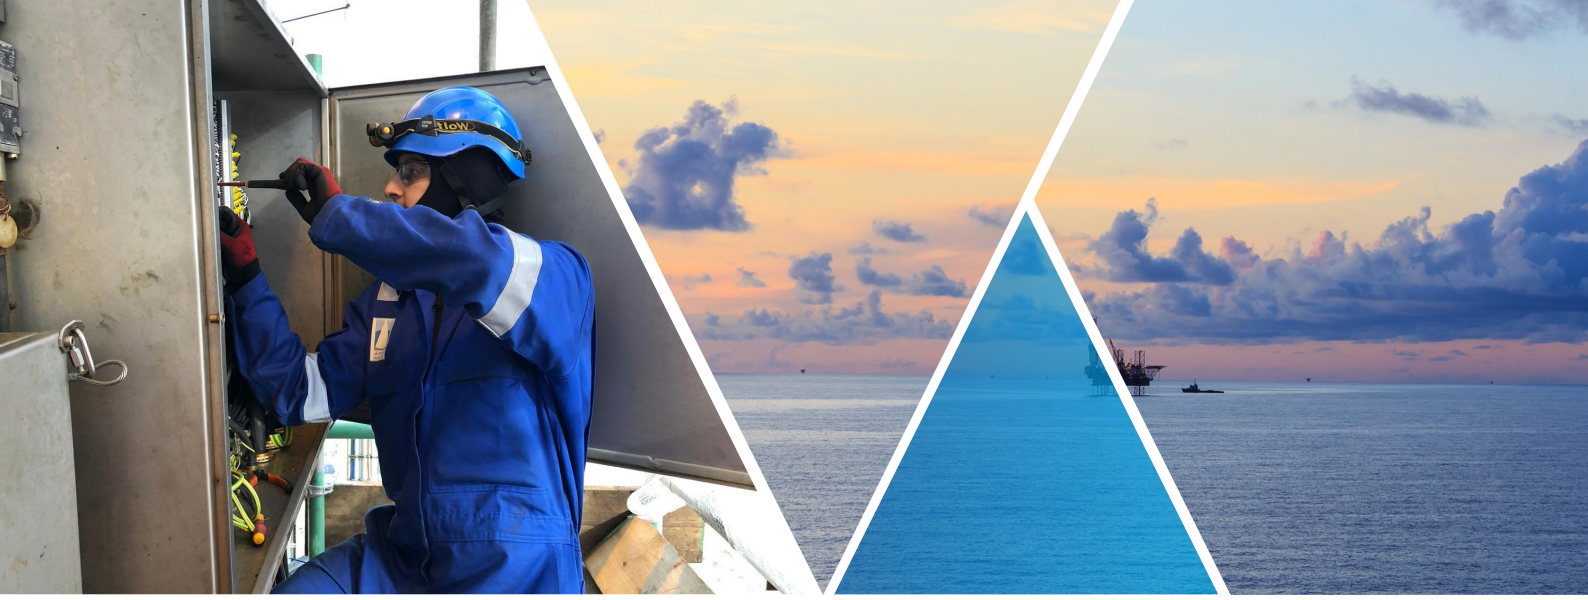
Overhauled aspirated panel

All the overhauled aspirator gas detector panels are once again fully functional and include upstream anti condensate filtration. The operator has a stock profile of critical spare parts to ensure future operations are maintained, and exposure to contamination is mitigated.
